#### FLORENCE COPPER INC.

Weekly Monitoring Report for Week Ending 11/16/2019

Florence Copper, Production Test Facility

Aquifer Protection Permit No. 106360, LTF 61845

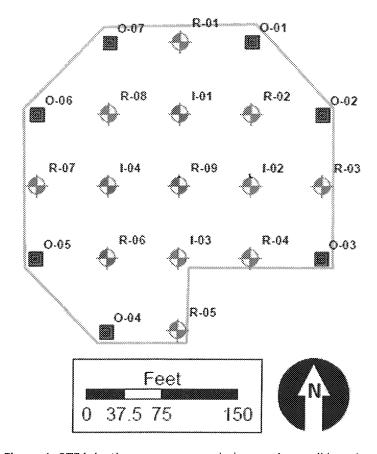
Figure 1. PTF injection, recovery, and observation well locations

A map showing the location of the PTF injection, recovery, and observation wells is included as Figure 1.

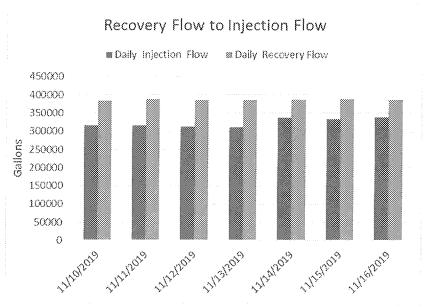
Figure 2. Recovered volume to injected volume

A summary of the injected and recovered volumes for the week of 11/10/2019 to 11/16/2019 is included in Table 1. The total injected and recovered volumes for the PTF as a daily total are also presented on Figure 2.

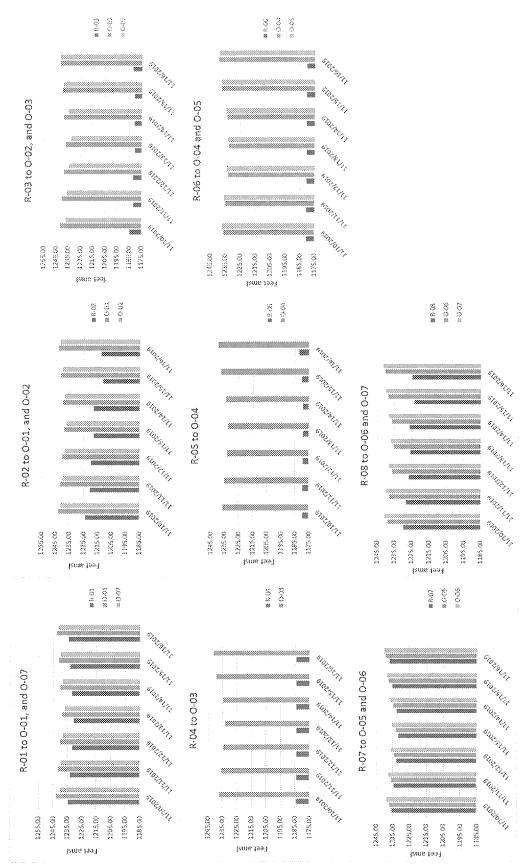
Figure 3. Recovery and observation well pairs

Table 2 includes a summary of water levels in the recovery and observation well pairs. Hydrographs showing the water level elevation for each recovery well and observation well pair are included in Figure 3.
